# GORILLA GLUE: Reviving the 25 Acre Roof

**Project Overview**  
Silicone Restoration over  
an EPDM Roof

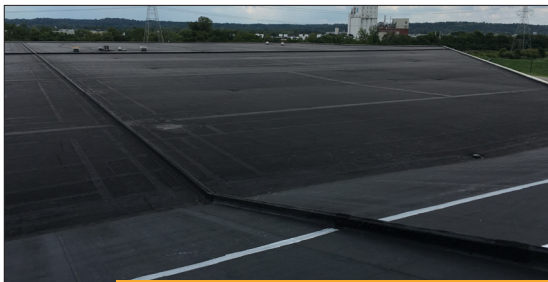
Before

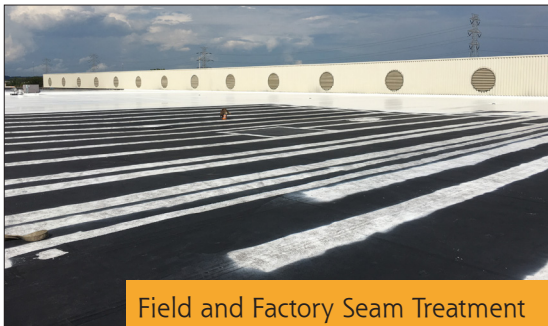
Field and Factory Seam Treatment

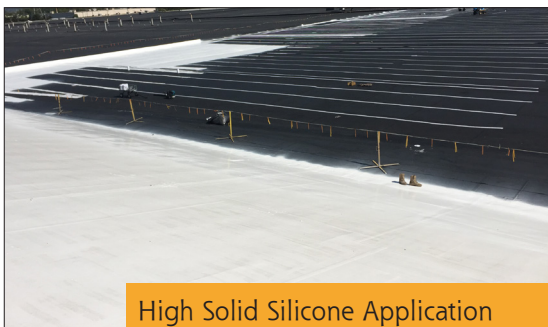
High Solid Silicone Application

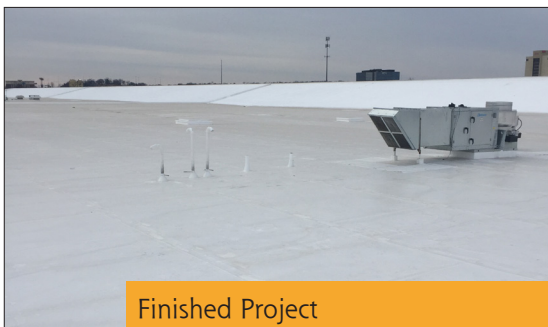
Finished Project
